Field Investigation Report

Remote Sensing For Evaluating
Post-Disaster Damage Conditions

The Pierre, S.D. Tornado
July 23, 1973

Alvin E. Rusche and Victor I. Myers

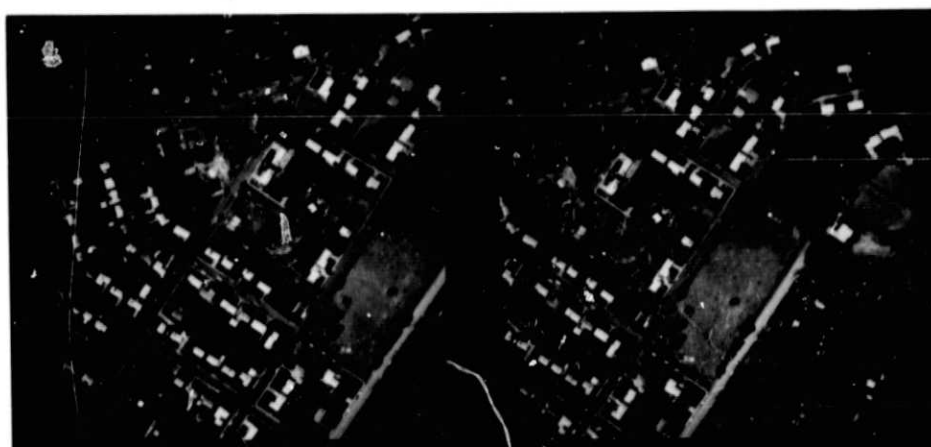
Figure 1.

Roof damage, object dislocation, destroyed structures and scattering of debris can be easily identified on these vertical photographs. Note that the debris has already been cleared from the streets, even though the data collection mission was flown the day following the tornado damage.

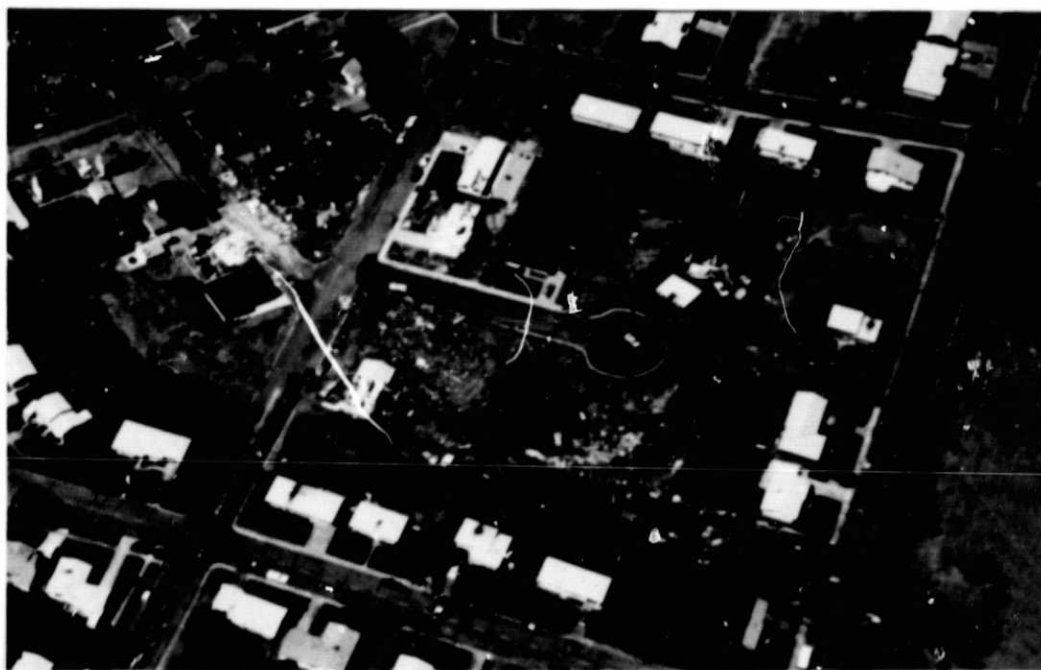
Figure 2.

The oblique photograph in Figure 2 provides additional information to the photo interpreter in that the vertical sides of structures can be seen and evaluated for damage. Heavy tree cover within a damaged area could make this type of imagery difficult to obtain. In that case, ground photography may be necessary to observe damage to verticle structures.

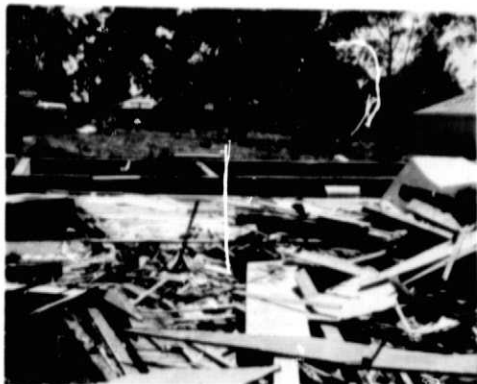
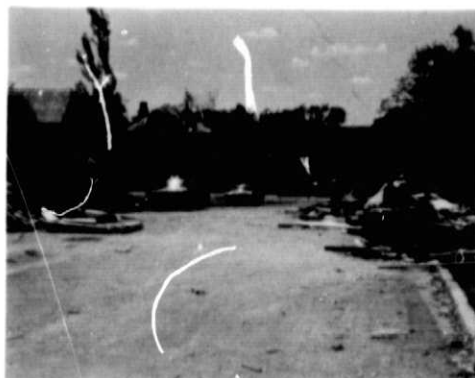
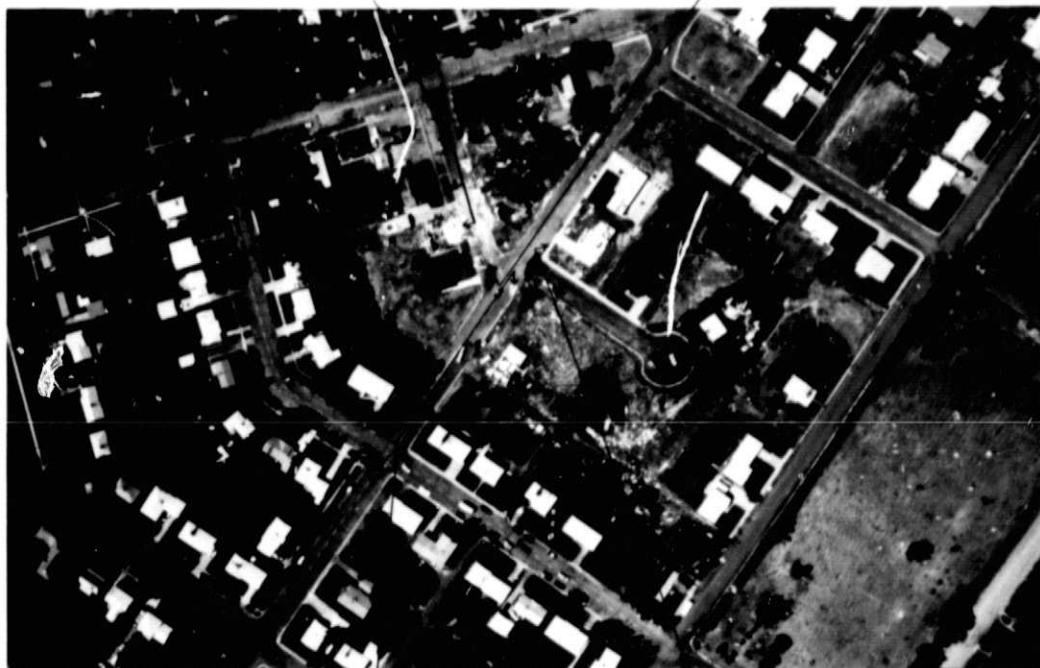
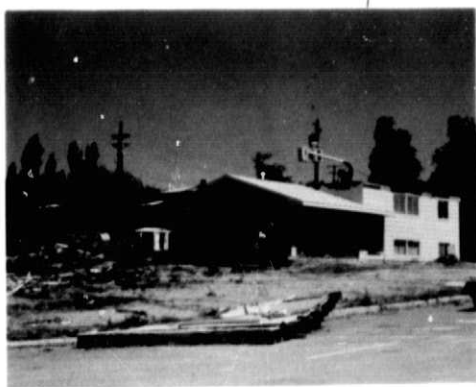
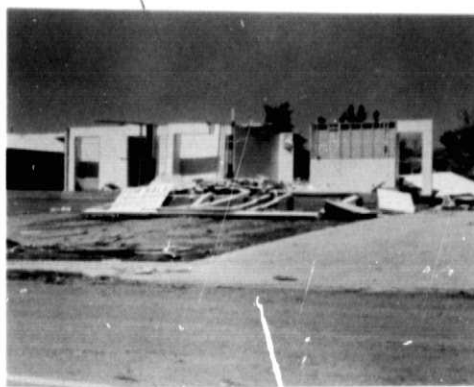
Figure 3.

The series of ground photographs displayed in figure 3 are keyed to an enlarged vertical view of part of the damaged area. These photos are useful for further documenting the extent of destruction.

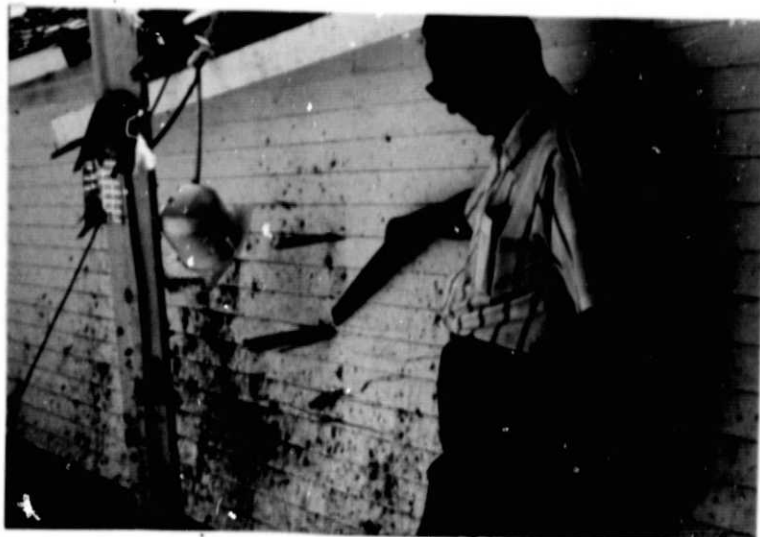
Figure 4.

Figure 4 shows small pieces of debris which were propelled by the tornado winds with sufficient force to penetrate the side of a building.

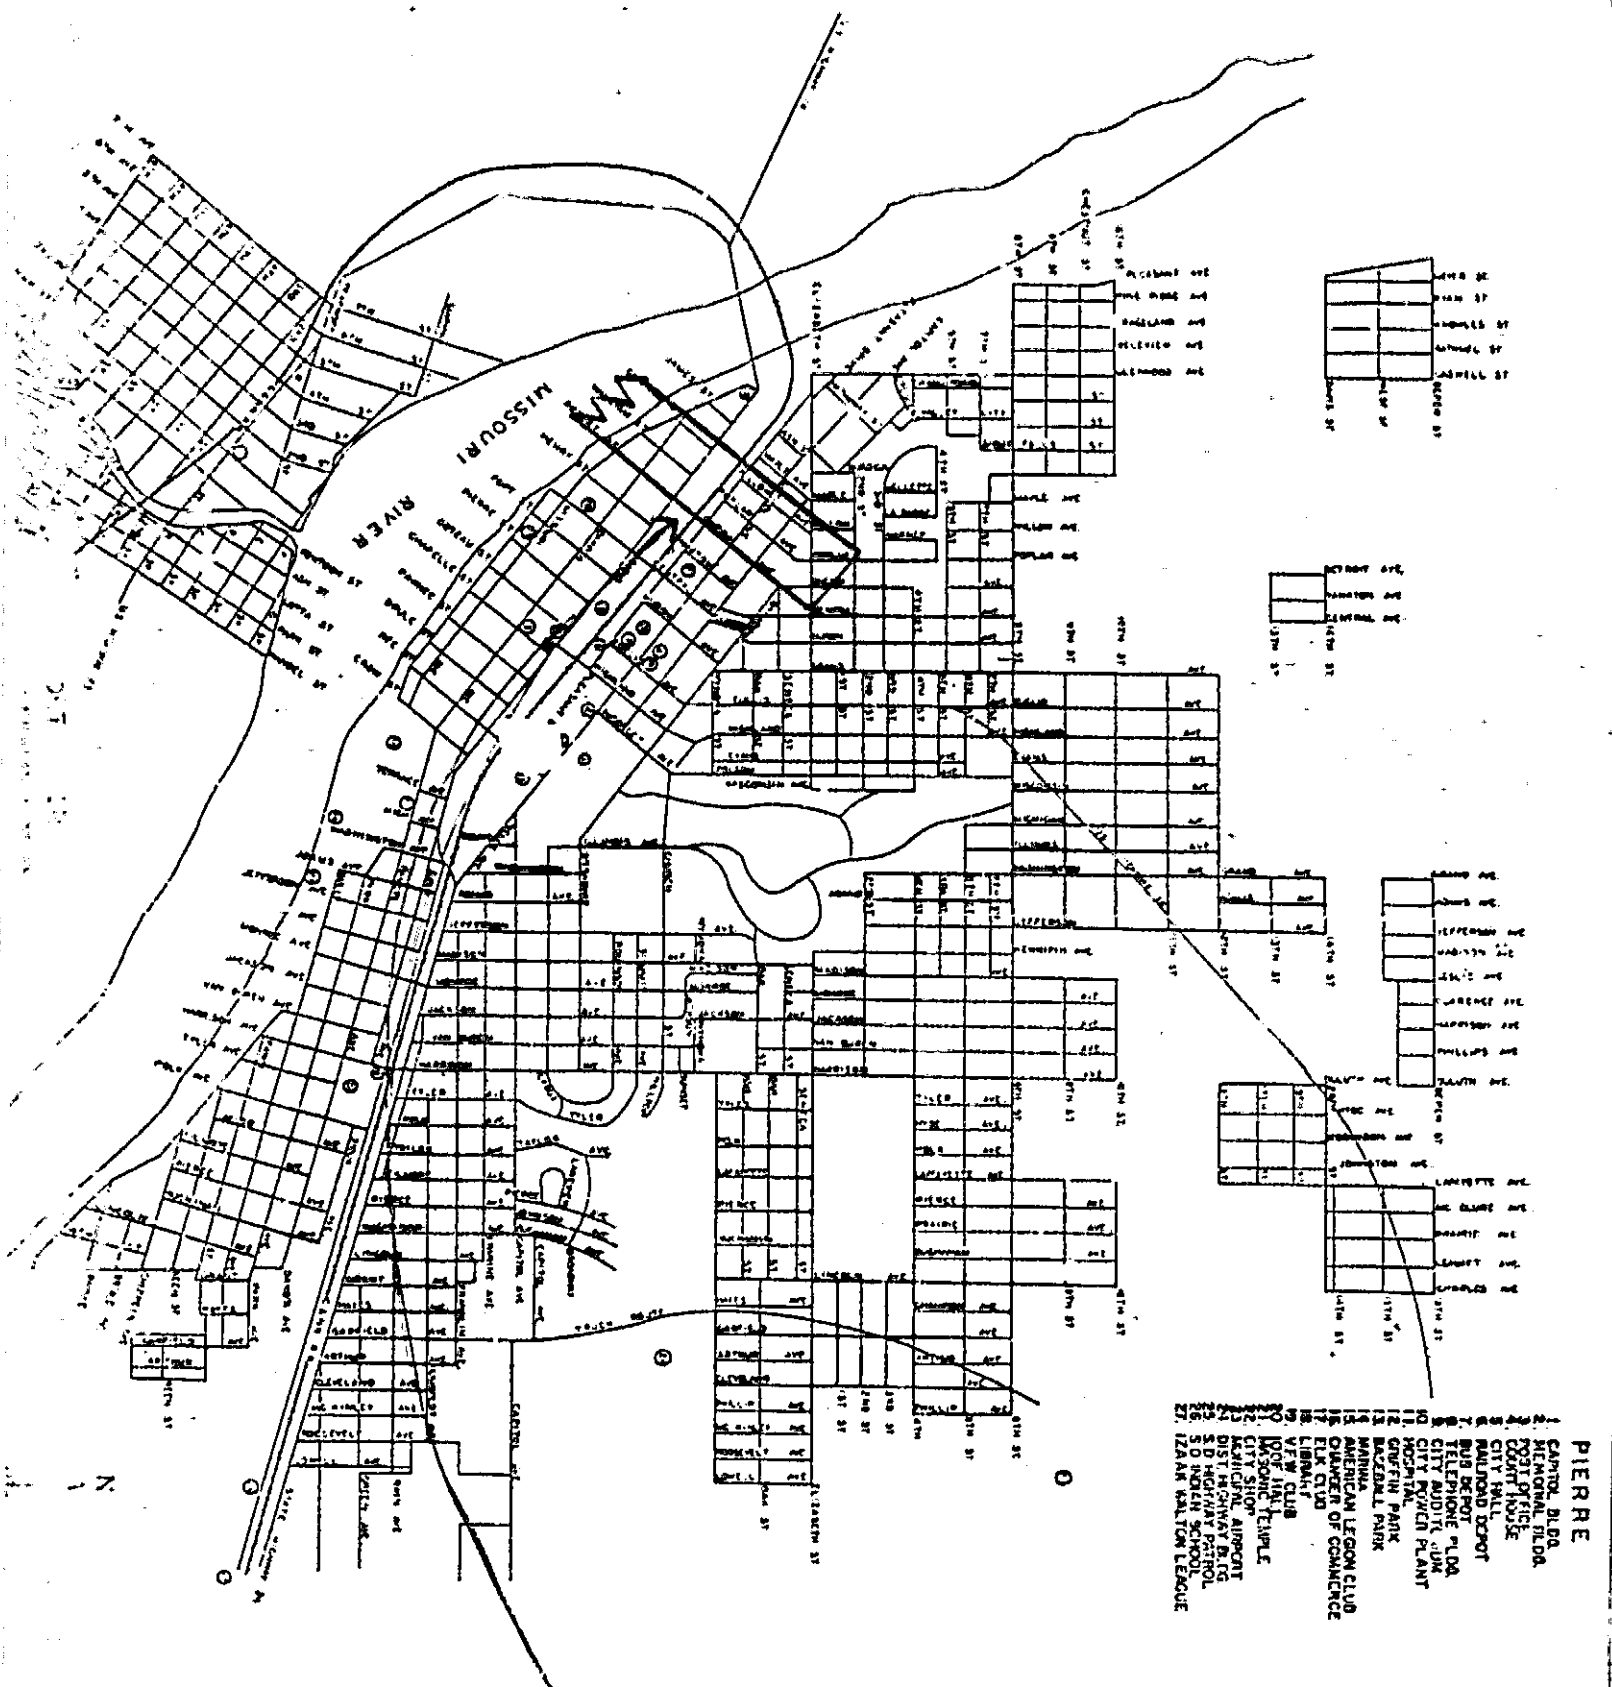
Enclosure 1

At about 3:45 P.M. on Monday, July 23, 1973, a tornado struck the city of Pierre, South Dakota. The tornado emerged from a heavy rain-shower area southwest of the city, descended over the river and moved northerly along Williams Street. (see enclosure 1). Approximately 20 city blocks were affected by the storm, with major damage occurring in the six block area bounded by Williams Street, Willow Avenue, Missouri Avenue and Second Street.

DAMAGE AREA - PIERRE TORNADO
JUNY 23, 1973
